SUBMITTAL SHEET

SURGE GUARD SERIES 10X STRONGER THAN SCHEDULE 80 TEES

Development of a Protocol to Determine the Cyclic Strength of PVC Pipe Fittings when Stressed to Failure

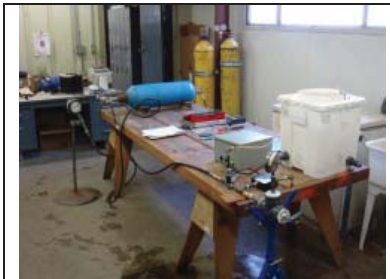
Figure 1. Test bench general arrangement

Major components built into the testing jig (see Figure 1) are described as follows:

1. **Nitrogen tank (yellow) equipped with a pressure regulator.** This arrangement is capable of supplying a controlled supply of gas at pressures to 3000 psi.

2. **Gas over water bladder tank (blue).** With a pressure-controlled gas inlet, the tank is capable of delivering a supply of water to the test jig at a specified pressure in a pulse-free manner. For these tests the water pressure was set at 250-260 psi. The supply pressure gauge is visible near the end of the tank.

3. **Three-way solenoid valve.** On signal from the timer circuit (see Figure 2), the solenoid valve alternately opens, thereby pressurizing the PVC tee, and closes thereby isolating the supply and depressurizing the PVC tee. For these tests, a 34-second cycle was used subjecting the tee to 17 seconds at 250 psi followed by 17 seconds at atmospheric pressure. The timer circuit also has a relay and an electrically-actuated cycle counter. The timer is a model H3C-R as manufactured by Anly Electronics Co, Ltd.

4. **A data logger** is required to record the maximum cycle pressure and document the time when the fitting failed. A model DLI2 by Dwyer Instruments was selected.

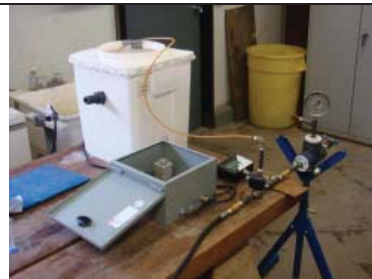
Figure 2. 2-in. Surge Guard PVC tee installed in the test jig with related components

Figure 2 also shows a Surge Guard PVC tee installed in the test jig. The tee sockets are fitted with schedule 40 2-in. x 1/2-in. reducer bushings (SP x F). The solvent welding was accomplished using IPS P70 primer and IPS 711 solvent cement. A pressure gauge is fitted into the vertical connection. A ball valve is fitted into the downstream port and is used to vent the air in the system. During the test, the lab room temperature was kept between 60° and 65° F. The failure crack shown in Figure 3 is representative of the location noted in all test work.
